USACE		Site Location: Bradford Island Landfill, In-Water Investigation	Project No. 52-00080001.04
Photo No. 2.4-1	Date: May-01

PHOTOGRAPHIC LOG

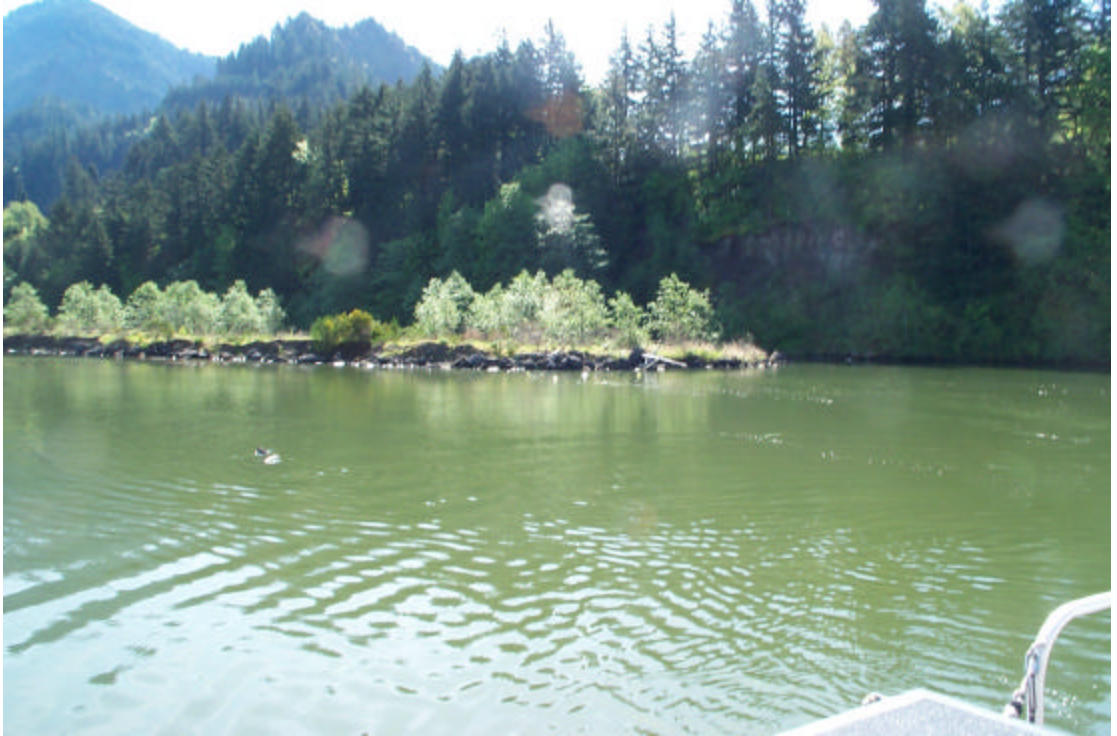
Direction Photo Taken: Southwest			
Description: Goose Island: Background Sampling Location

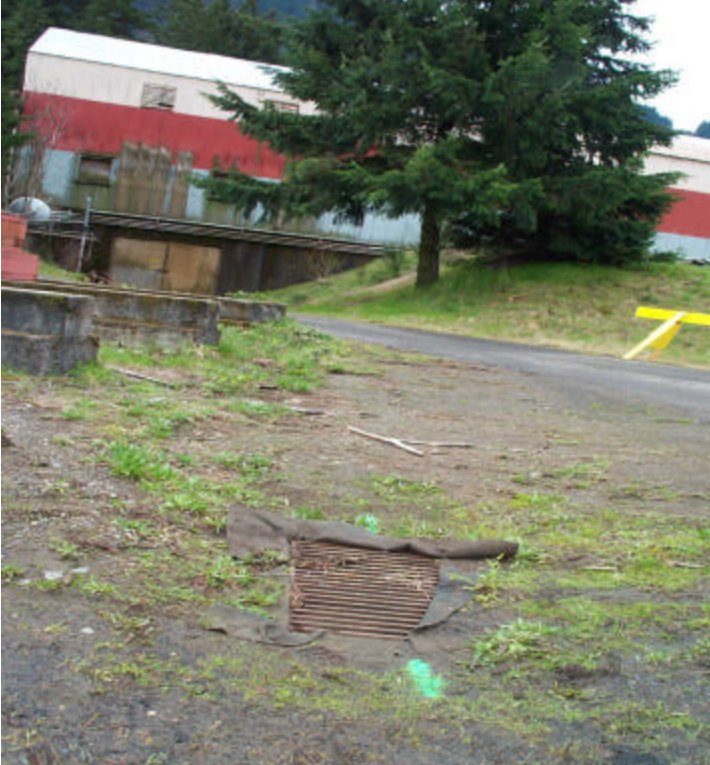
USACE		Site Location: Bradford Island Landfill, In-Water Investigation	Project No. 52-00080001.04
Photo No. 2.6-1	Date: Mar-01

Direction Photo Taken: South			
Description: Sandblast Building Drain Catch Basin #1

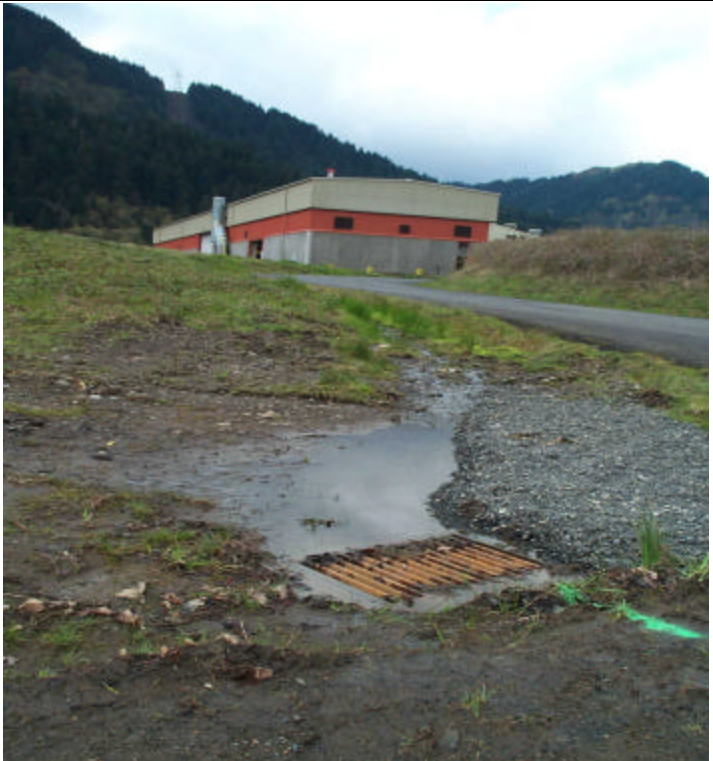
USACE		Bradford Island Landfill, In-Water Investigation	52-00080001.04
Photo No. 2.6-3	Date: Mar-01

Direction Photo Taken:			
South			
Description:			
Sandblast Building Drain Catch Basin #2

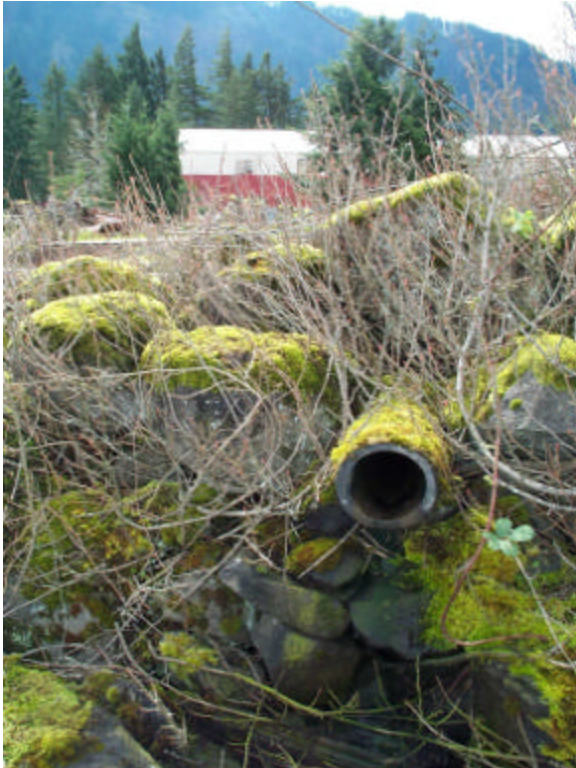
USACE		Site Location: Bradford Island Landfill, In-Water Investigation	Project No. 52-00080001.04
Photo No. 2.6-5	Date: Mar-01

Direction Photo Taken: Southwest			
Description: Sandblast Building Drain Outfall #1.

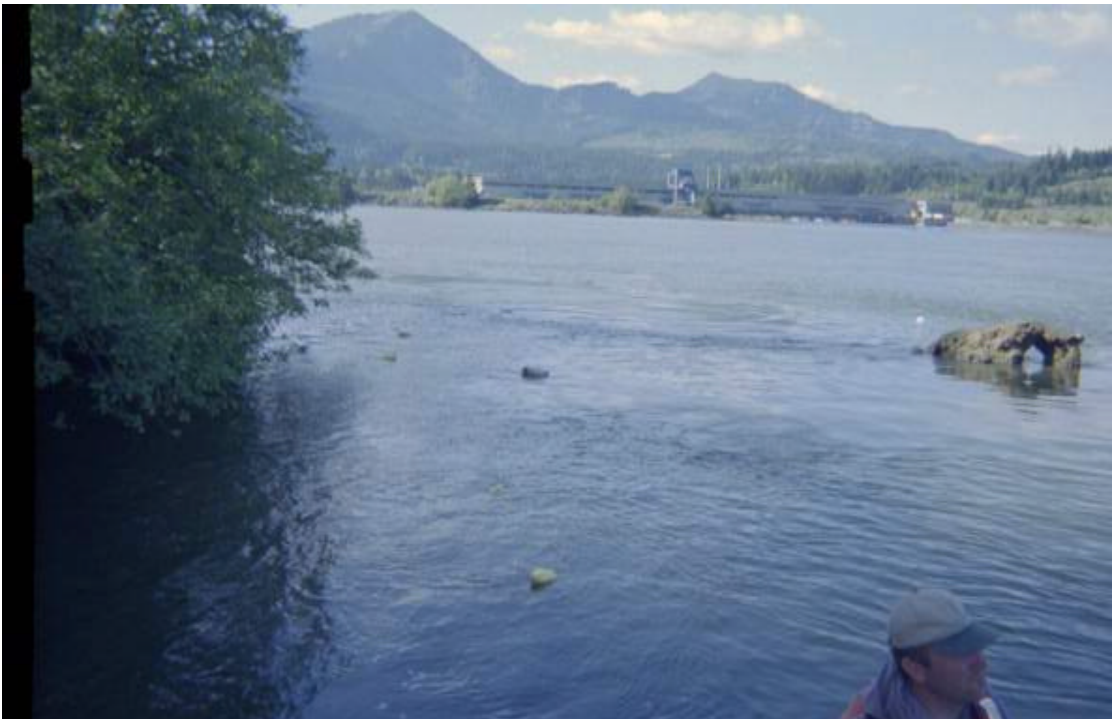
USACE		Site Location: Bradford Island Landfill, In-Water Investigation	Project No. 52-00080001.04
Photo No. 2.4-3	Date: May-01

Direction Photo Taken: Northwest			
Description: Upstream Debris Pile SPMD Anchors and Crayfish Traps
